## ANALYSIS OF A FORD SPEED CONTROL DEACTIVATION SWITCH FIRE.

BY JEFFERY T MORRILL, CFI, CVFI; MARIETTA, GEORGIA—The investigation of a vehicle fire is often a complex and daunting task. Occasionally, when a situation arises that is so widely publicized as the recent recall of nearly four-million Ford vehicles, even the experienced fire investigator tends to view these losses with a bit of tunnel-vision.

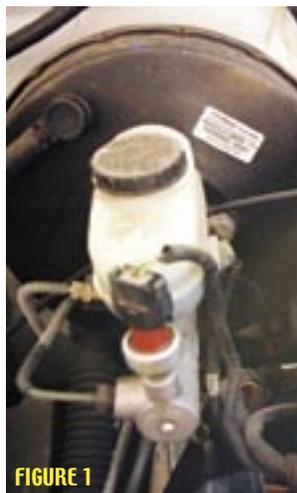
FIGURE 1

This switch is responsible for energizing the brake lights and deactivating the cruise control system. The second (redundant) switch is pressure activated and mounted on the brake master cylinder. There are two mounting orientations that Ford uses. The most common is a vertical orientation as shown in Figure 1, and the second is a 45 degree down orientation as shown in Figure 2

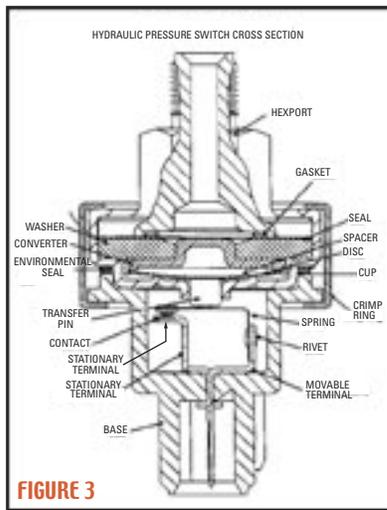
FIGURE 3

The SCDS should only function to deactivate the cruise control if the brake light switch fails; otherwise, this switch is normally closed and carries the electrical load of the cruise control system. The SCDS was manufactured by Texas Instruments design to a Ford specification design. Texas Instruments has stated the switch was only designed to handle a small (1-2 amperes) intermittent DC load. Ford installed the switches in a 15 ampere circuit. Additionally this circuit is energized at all times. Ford stated this was necessary as the switch is in the brake light circuit and must therefore be continuously energized. Figure 3 is a diagram of the switch components.

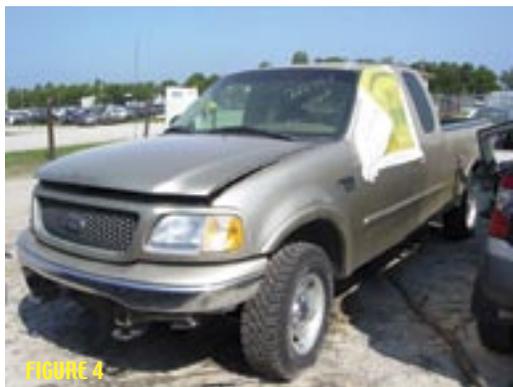
FIGURE 4

As an objective investigator, you must inspect every vehicle without presumption and evaluate the evidence on its merits. A typical vehicle investigation starts with an overall view of the vehicle, noting any exterior burn damage. Depending on how long they burned, damage from a SCDS fire may be minor, major or total, such as shown in Figures 4, 5, or 6.

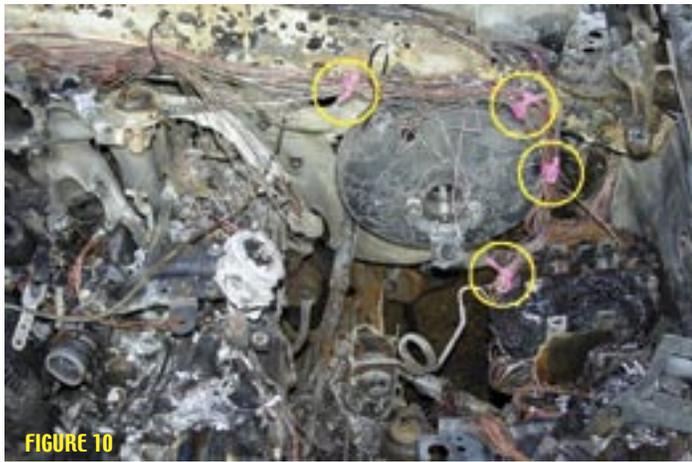
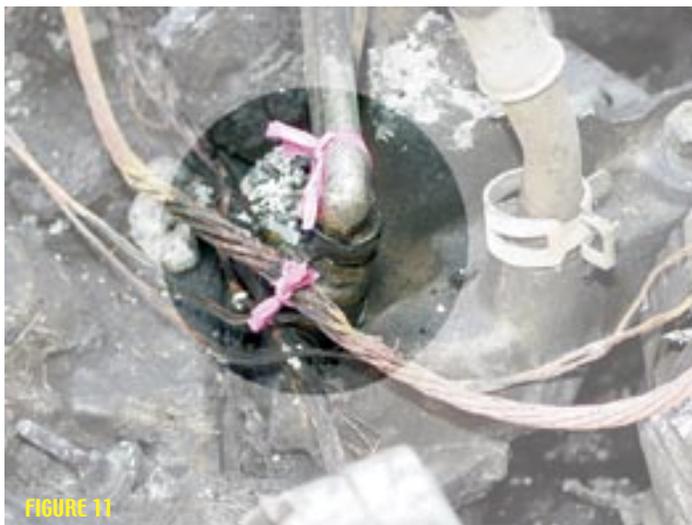
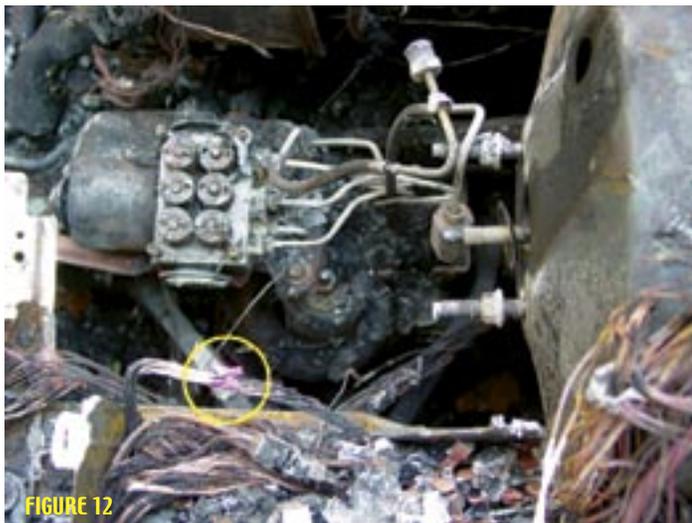
ment. Again, this alone does not mean the switch failed and started the fire. It is only an indicator that there was electrical activity on the driver's side of the engine compartment prior to the battery being depleted. The identification of the areas of electrical activity can be marked with a colored ribbon so as to show better in a photograph. Figures 10, 11, and 12, are examples of the identification of electrical activity and how it can be marked.

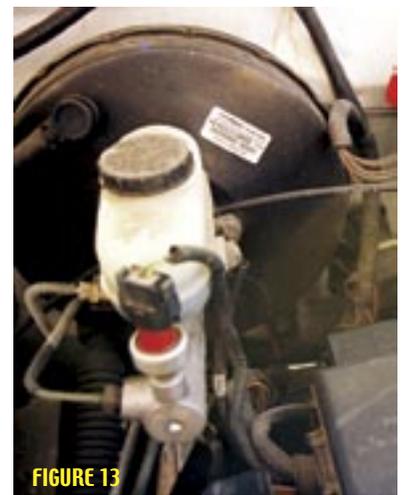
Figure 13 is a view of an undamaged SCDS mounted vertically on the forward end of the master cylinder.

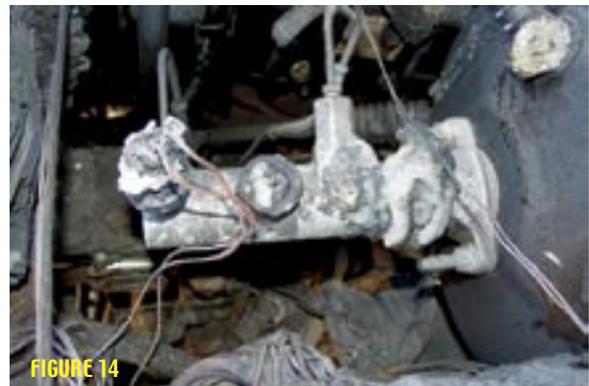
If the switch is still completely intact, in its pre-fire position on the end of the master cylinder, it is recommended that the entire master cylinder be removed and retained. This is the easiest way to recover the switch without any further physical damage. If the wires are still attached, they should be cut back a distance away from the switch. A switch that has not been detached from the master cylinder will typically look like Figure 14.

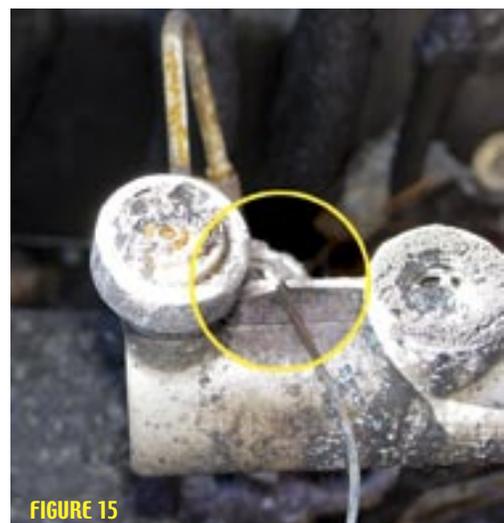
Often the electrical (base) portion of the switch will be detached from the hexport (body). The electrical portion may still be attached by the wiring or may have fallen to the inside of the driver's side front tire. A hexport with a detached electrical section may look like the one shown in Figure 15 (the electrical portion is hanging over the master cylinder and still attached by one wire).

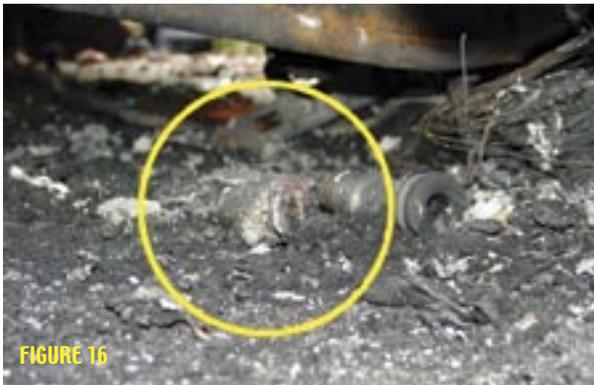
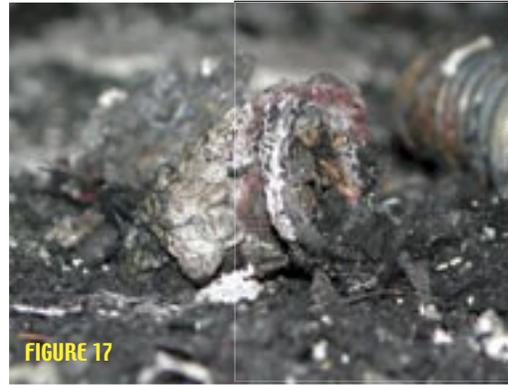
When the fire reaches sufficient intensity, the master cylinder will fail, and the switch parts will fall to the ground. Identification and recovery of the switch parts becomes more complex and difficult. Typically, the electrical section will fall ahead of the axle and the hexport will fall to the rear of the axle, but both will be to the inside of the driver's front tire. This area is subject to the actions of fire suppression and vehicle recovery. If the vehicle is slid over the ground, as in a roll-back recovery operation, the switch electrical remains can be crushed. Figures 16 and 17 show the electrical section in the debris under the vehicle.

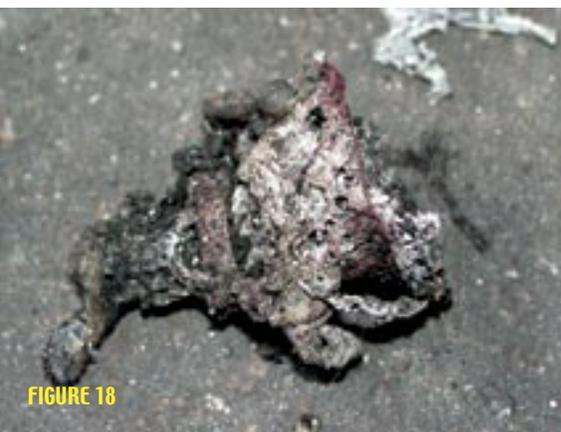
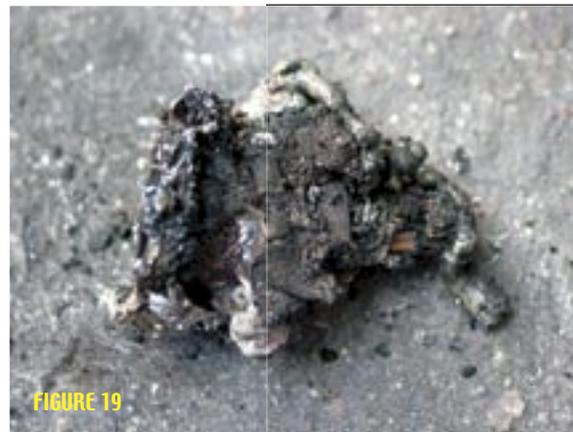
Figures 18 and 19 show the electrical section after recovery from the debris.

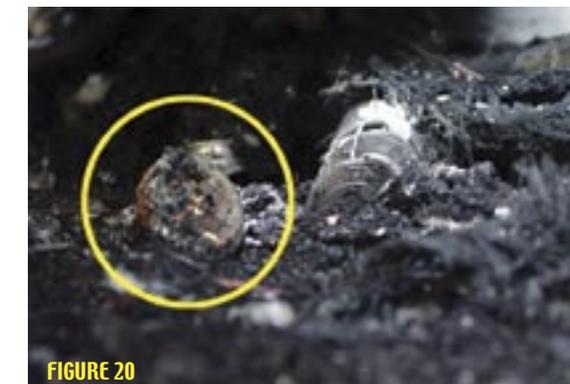
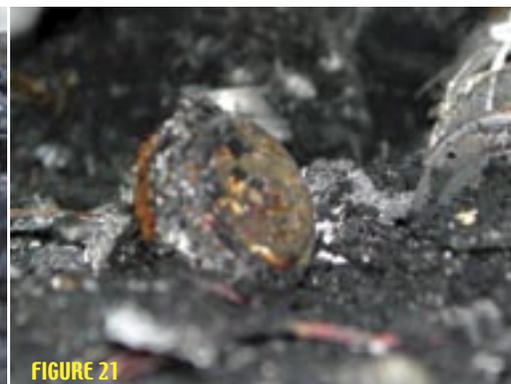
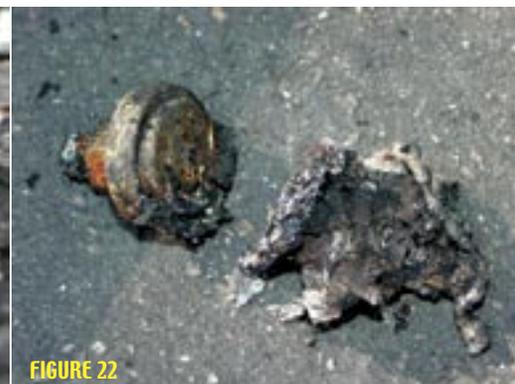
The hexport will also be found in the debris as shown in Figures 20 and 21 and after recovery in Figure 22.

Once these items are recovered, they should be placed in a plastic bag, then padded and placed in a metal can to protect the pieces from further harm.

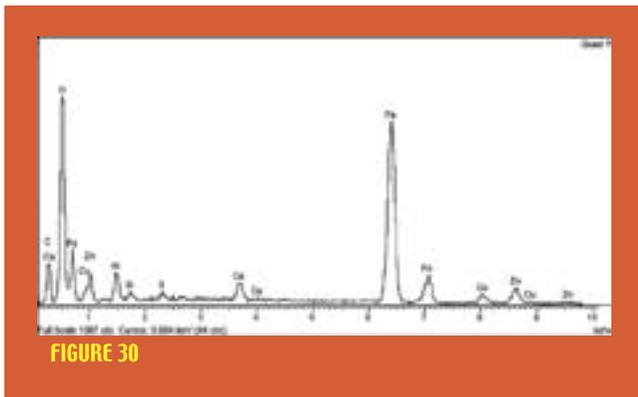
FIGURE 30

A recovered hexport from a failed SCDS will typically look like the one shown in Figure 28. Using the SEM, photomicrographs can be taken of the four quadrants (Figure 29 shows quadrant 1) and the EDS scan of the surface (Figure 30) will show the presence of copper if the electrical portion of the switch has failed.

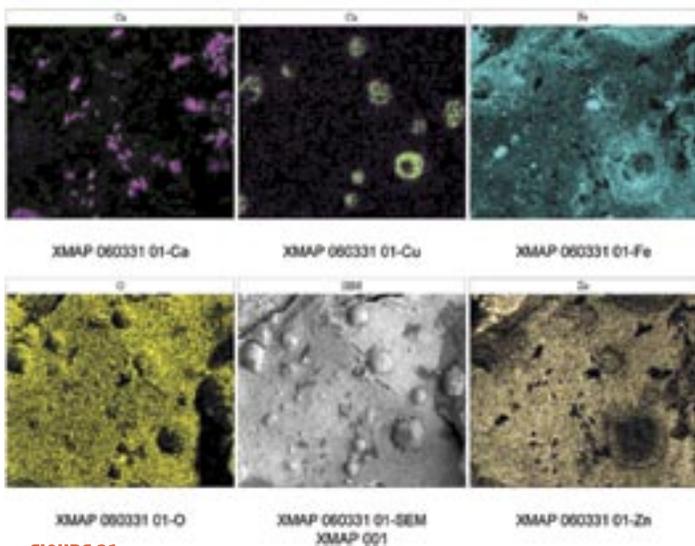
FIGURE 31

An SEM/EDS with elemental mapping capability can visually show the location of melted copper on the hexport face (Figure 31).
