## ANALYSIS OF A FORD SPEED CONTROL DEACTIVATION SWITCH FIRE.

BY JEFFERY T MORRILL, CFI, CVFI; MARIETTA, GEORGIA—The investigation of a vehicle fire is often a complex and daunting task. Occasionally, when a situation arises that is so widely publicized as the recent recall of nearly four-million Ford vehicles, even the experienced fire investigator tends to view these losses with a bit of tunnel-vision.

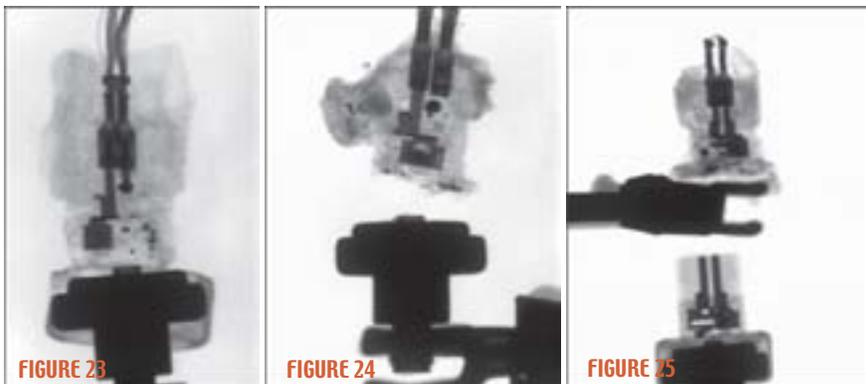
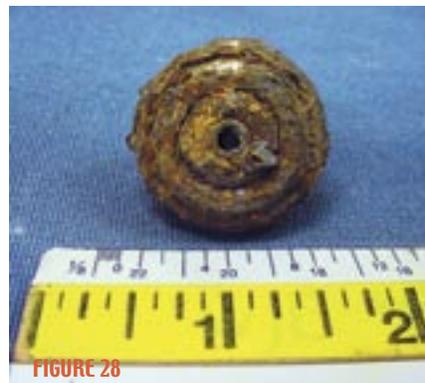
When the electrical section is not recovered, the hexport can still be analyzed. The use of a Scanning Electron Microscope with Energy Dispersive X-Ray Spectroscopy (SEM/EDS) allows the presence of copper to be visualized. In a normally functioning switch, there should be no copper on the face of the hexport. Figure 26 shows a new hexport and Figure 27 is the accompanying EDS spectrum. The zinc (Zn) indicates galvanized steel.

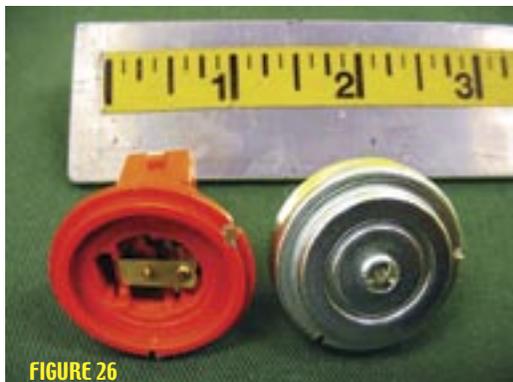
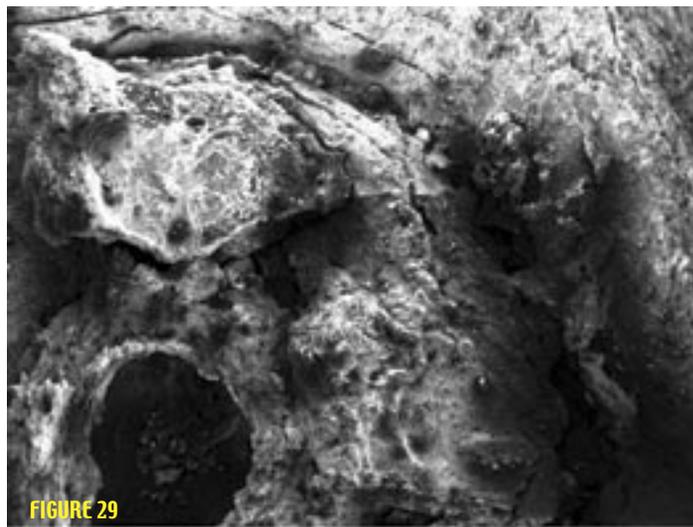
A recovered hexport from a failed SCDS will typically look like the one shown in Figure 28. Using the SEM, photomicrographs can be taken of the four quadrants (Figure 29 shows quadrant 1) and the EDS scan of the surface (Figure 30) will show the presence of copper if the electrical portion of the switch has failed.

An SEM/EDS with elemental mapping capability can visually show the location of melted copper on the hexport face (Figure 31).
